Preventive Thermographic Diagnostic of a HV Busbar Disconnecter

Original Research Paper
DOI: 10.7251/ELS1620003S

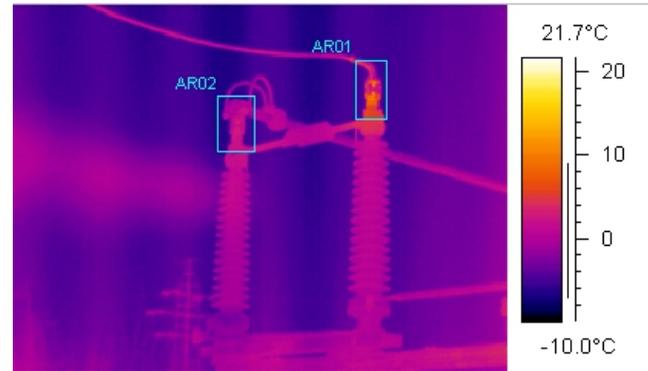
Figure 5. Thermogram of the busbar disconnector F0 in TL 110 kV Goražde 2 in the FU 110/35/20/10 kV Goražde 1

On the basis of the recording from 2014, the heating at the busbar disconnector F0 at the transmission line TL 110 kV Goražde 2 was noticed in the FU 110/35/20/10 kV Goražde 1. The thermogram of this disconnector is shown in Figure 5.

During the recording, the environmental temperature was -3°C , and the air humidity was 74% RH. The current per a phase was 100 A. The analysis showed the heating at the contact to the busbar (AR01 area in Figure 5). The temperature was 10.6°C . When it is compared to the environmental temperature and other (AR01, temperature 6°C), it can be concluded that the heating occurs at the contacts to the busbar and the repairing of the heating place is recommended. After thermographic recordings and noticed heating, the repairing of the heating place was performed. Before the repairing, the voltage drop of 204mV had been measured at the heating place, and after the performed repairing it was 10.25m Ω .

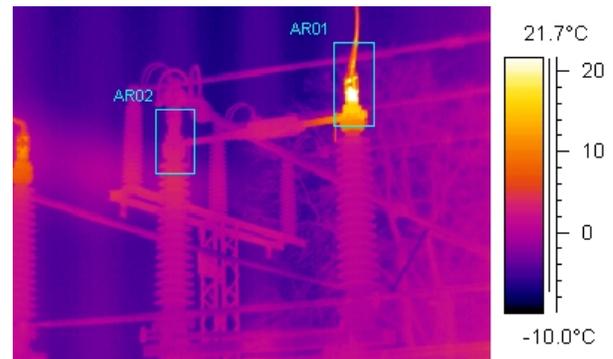
Figure 6. Thermogram of the busbar disconnector F4 in TL 110 kV Goražde 2 in the FU 110/35/20/10 kV Goražde 1

The next heating was noticed at the busbar disconnector in the transmission line TL 110 kV Goražde 2 was noticed in the FU 110/35/20/10 kV Goražde 1. At During the recording, the environmental temperature was -3°C , and the air humidity was 74% RH. The thermogram of this disconnector is shown in Figure 6.

During the recording, the current per a phase was 100 A. By a detailed analysis of thermogram, an increased heating can be noticed at the contacts to the busbar (AR01). The temperature of a contact was 31.2°C , while by the comparison to the contact on the other disconnector, where the temperature was 7°C , it can be concluded that an increased heating occurs at the contacts between disconnectors and busbars. During the repairing, the voltage drop of 316 mV had been measured at the heating place, while after the removal of the named defect the voltage drop at the contact was 11.35 mV.

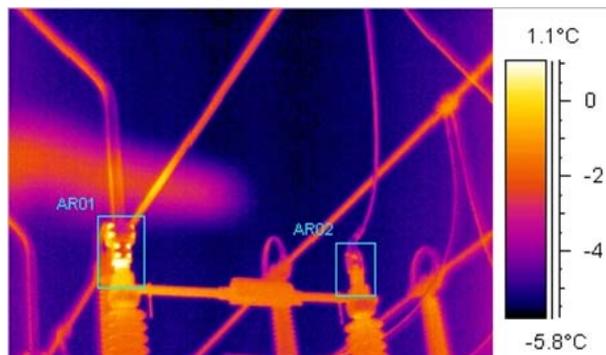
Figure 7. Disconnector F0 in TL 110 kV Višegrad in the FU 110/20/10 kV Goražde 2

During the testing in 2015, the heating on particular disconnectors was noticed in the FU 110/20/10 kV Goražde 2. The analysis of the thermogram showed the heating at the busbar disconnector F0 in the transmission line field transmission line (TL) 110 kV Višegrad. The thermogram of this disconnector is shown in Figure 7.

During the recording, the environmental temperature was -4°C , and the air humidity was 66% RH. At this part of the facility, the current per phase was 103 A. On the basis of the analysis of the thermogram, it can be seen that there is an increased heating at the contact of the disconnector towards the switch (AR01). The temperature of the contact was 5.8°C . After the heating had been noticed, the repairing of the contact was performed. During that, a voltage drop of 98.8 mV had been measured at the contact. After the repairing (cleaning and tightening of connections), the voltage drop at the same place was 13.1 mV.

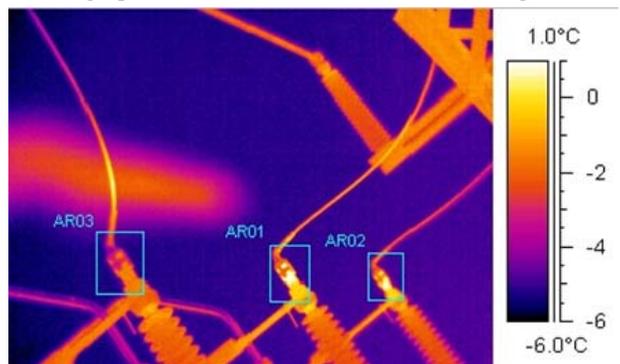
Figure 8. Thermogram of the disconnector F0 and F4 in TL 110 kV Goražde 1 in the FU 110/20/10 kV Goražde 2

The heating at the busbar disconnectors F0 and F4 in the transmission line TL 110 kV Goražde 1 was noticed. The thermogram of this disconnector is shown in Figure 8.

During the recording in this part of the plant, the current per phase was 100 A. The thermogram showed the heating at the contacts of the disconnectors towards the busbar (AR01 and AR02). The temperature of the heated contacts was 1.6°C (AR01), 1.1°C (AR02). During the repairing of the contacts, a voltage drop of 87.5 mV (AR01) and 84.3 mV (AR02) had been measured. After the repairing (tightening of the connections), the voltage drop was 2.01 mV and 1.94 mV.

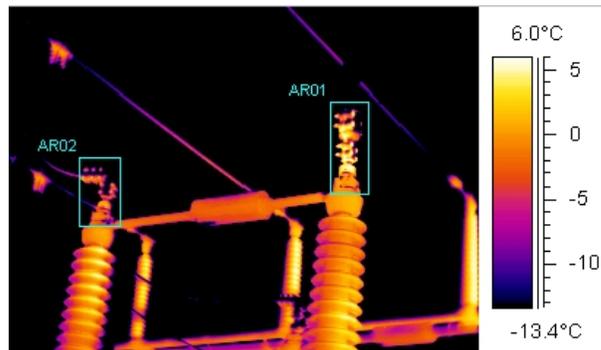
Figure 9. Thermogram of the disconnector F8 in TL 110 kV Višegrad in the FU 110/10/35 Rogatica

At the Figure 9 shown thermogram of the disconnector F8 in TL 110 kV Višegrad in the FU 110/10/35 Rogatica.

During the recording, the environmental temperature was -9°C , and the air humidity was 38% RH. The current per a phase was 85 A. The analysis showed the heating at the contact to the busbar (AR01 area in Figure 9). The temperature was 7.1°C . When it is compared to the environmental temperature and other (AR01, temperature 1.3°C), it can be concluded that the heating occurs at the contacts to the busbar and the repairing of the heating place is recommended. After thermographic recordings and noticed heating, the repairing of the heating place was performed. Before the repairing, the voltage drop of 256mV had been measured at the heating place, and after the performed repairing it was 2.51mΩ.

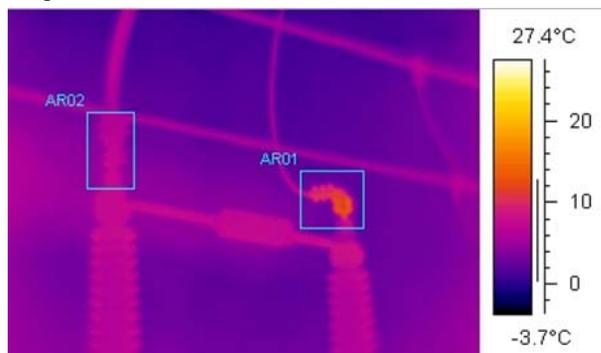
Figure 10. Thermogram of the disconnector F0 in the transformer field 1, 110 kV in the FU 110/10/35 kV Foča

The heating at the busbar disconnector F0 in the the transformer field 1, 110 kV in the FU 110/10/35 kV Foča was noticed. The thermogram of this disconnector is shown in Figure 10.

During the recording, the environmental temperature was 5°C , and the air humidity was 75% RH. The current per a phase was 30 A. By the analysis of the thermogram at the contact of the disconnector towards the busbar, the temperature of 13.3°C was measured. If it is compared to the environmental temperature, it is concluded that an increased heating occurs at this contact and is recommended to repair the contact to prevent a bigger heating. At the repairing of the contact, the voltage drop of 127.8 mV had been measured. After the repairing (tightening of the contact) it was 2.14 mV.
